The Rambunctious Rim

A workman changing a flat tire on a large earthmover was injured, eventually losing a leg. The manufacturer was then sued. The case history follows the court hearings, providing details and opinions from both sides of the incident, allowing the student to be a member of the jury who decides the outcome.

THE RAMBUNCTIOUS RIM (A)

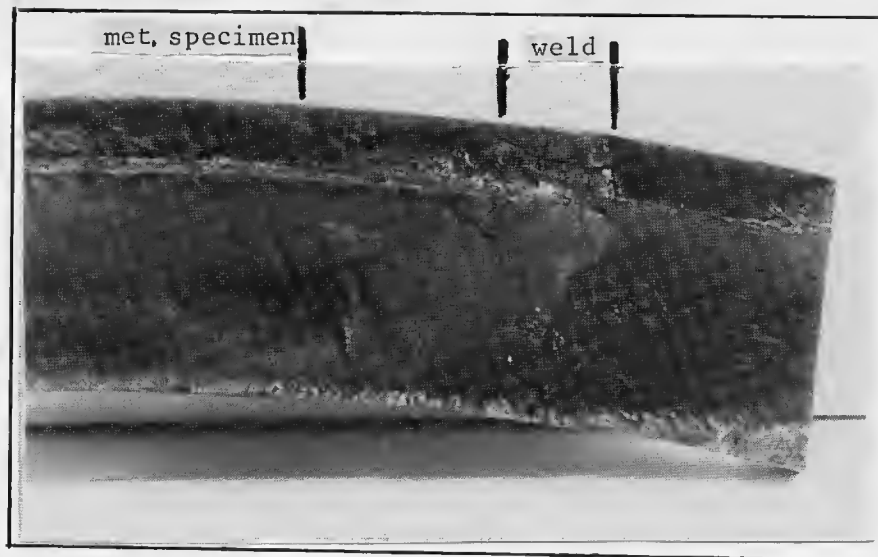
Exhibit A5 is a portion of the fracture surface in the vicinity of the weld in the rim base. Observe there is a relatively smooth region in the left portion of the fracture surface. At least ten such regions on the fracture surface had a relatively smooth area with "clamshell" markings surrounded by regions which were relatively rough and "woody" in appearance. One of these regions, adjoining the section partially shown in Exhibit A5, is shown in Exhibit A6.

The "hill and valley" appearance suggested the possibility of cracks of some sort present in the rim base when it was put into service. Consequently, dye penetrant and magnetic particle inspections were conducted with particular attention to the original surface of the gutter. Some results are shown in Exhibits A5 and A6.

A second metallographic specimen (MS 2) was taken from the separated ring as indicated in Exhibit A5. Magnetic particle inspection showed cracks at the weld but MS 2 was taken at a point where there was no obvious suggestion of a crack or other defect in the separated ring. A seam or fold was evident as shown in Exhibit A9.

Exhibit A5--Portion of fracture surface. A crack is visible (made visible by magnetic particle inspection) in the unfractured surface of the gutter. This crack is located at the weld in the rim base. Approx. 1.2X

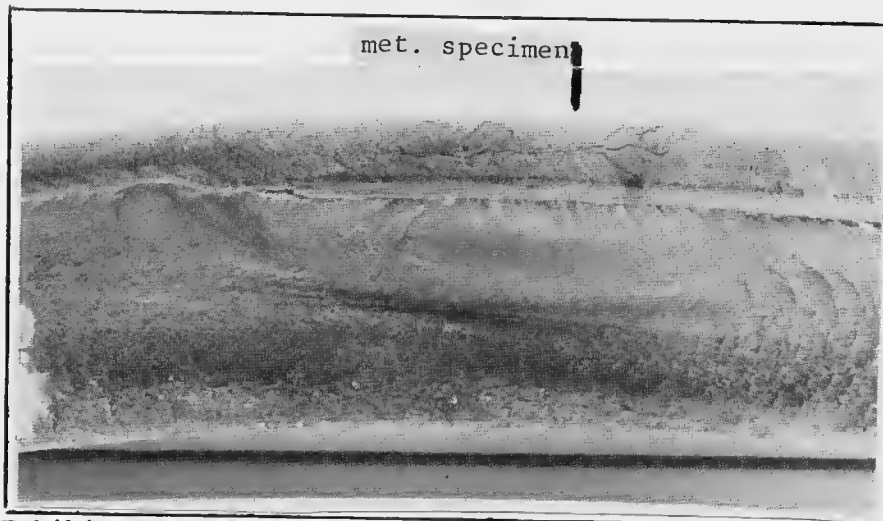
A metallographic specimen (MS 1) was taken from the separated ring as indicated in Exhibit A6. What appears to be a crack in Exhibit A7 starts at the place indicated in Exhibit A6 by the magnetic particle inspection, i.e., in the gutter surface at some distance from the edge of the fracture surface. It might be noted that this section of the separated ring was examined with dye penetrant with negative results before trying magnetic particle inspection. This indicates that the "crack" is an inclusion rather than a true crack.

Exhibit A6--Portion of fracture surface (center about 10 inches from weld in rim base). A crack is visible (made visible by magnetic particle inspection) in the unfractured surface of the gutter. Approx. 1.2X

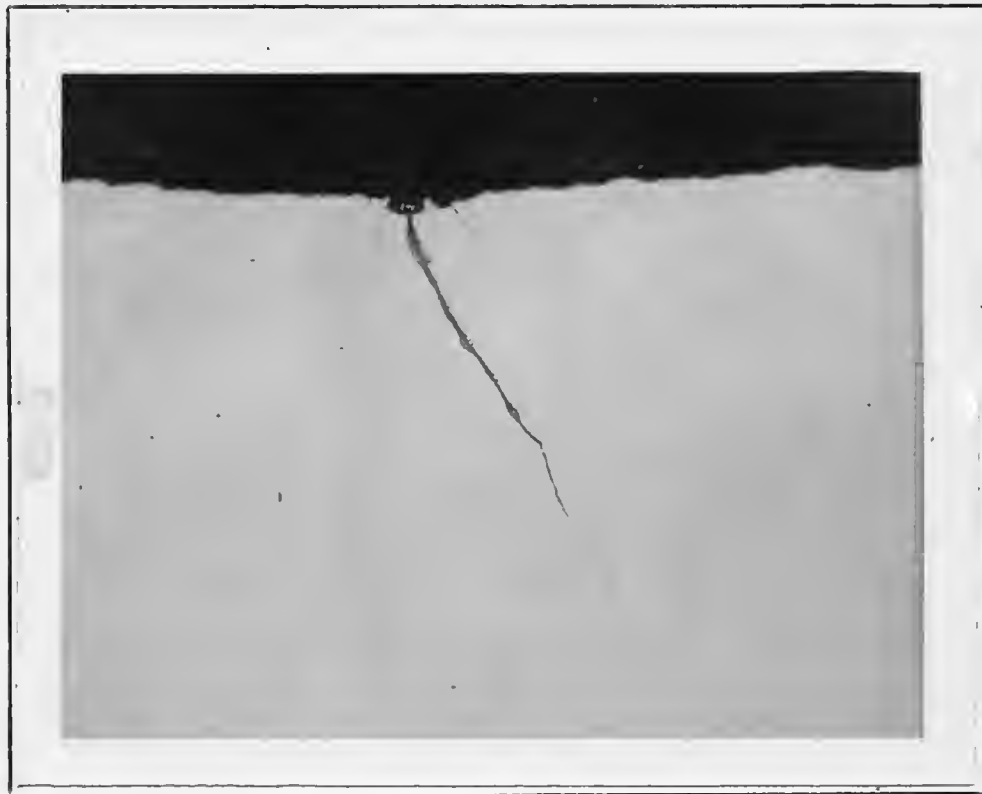
Faber questioned the quality of the weld in the rim base since the interface between the two sections being joined was so distinct. The presence of defects (Exhibits A8 and A9) at the fracture surface and an inclusion (Exhibit A7) was strong evidence that the individual failure regions started at such defects, in his opinion.

Exhibit A7 -- Metallographic specimen (MS1) (taken from separated ring as shown in Exhibit A6) showing an imperfection extending from the gutter surface into the body of the separated ring.

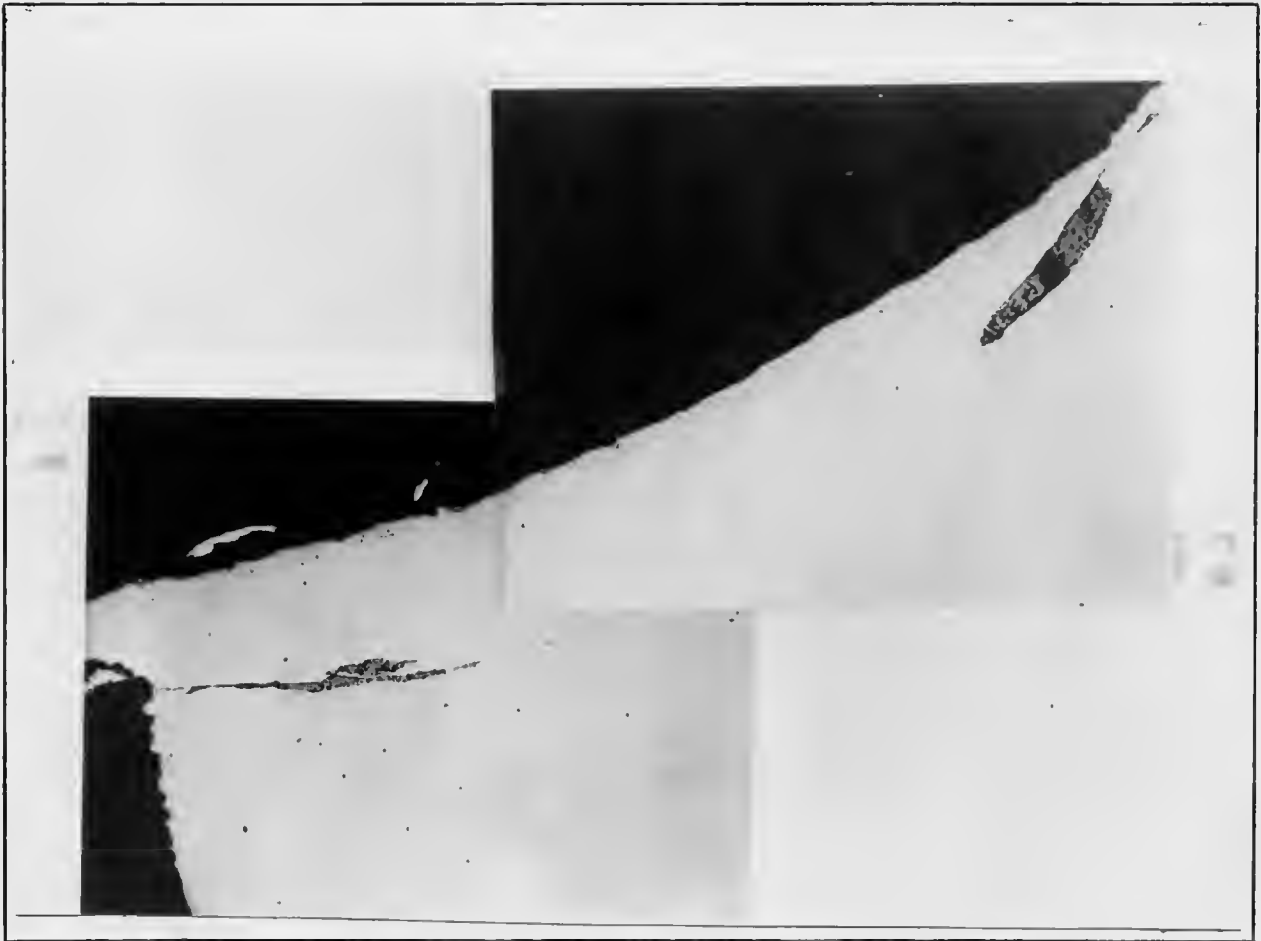
Exhibit A8 shows another region of MS 1 in which an inclusion starts at the fracture surface and runs under the gutter surface. At some distance away there is another inclusion under the gutter surface.

Exhibit A8 -- Metallographic specimen (MS1) showing inclusion under gutter surface (upper right) and an inclusion starting at the fracture surface (left) and extending under the gutter surface. When viewed under a higher magnification these two inclusions appear to be connected.

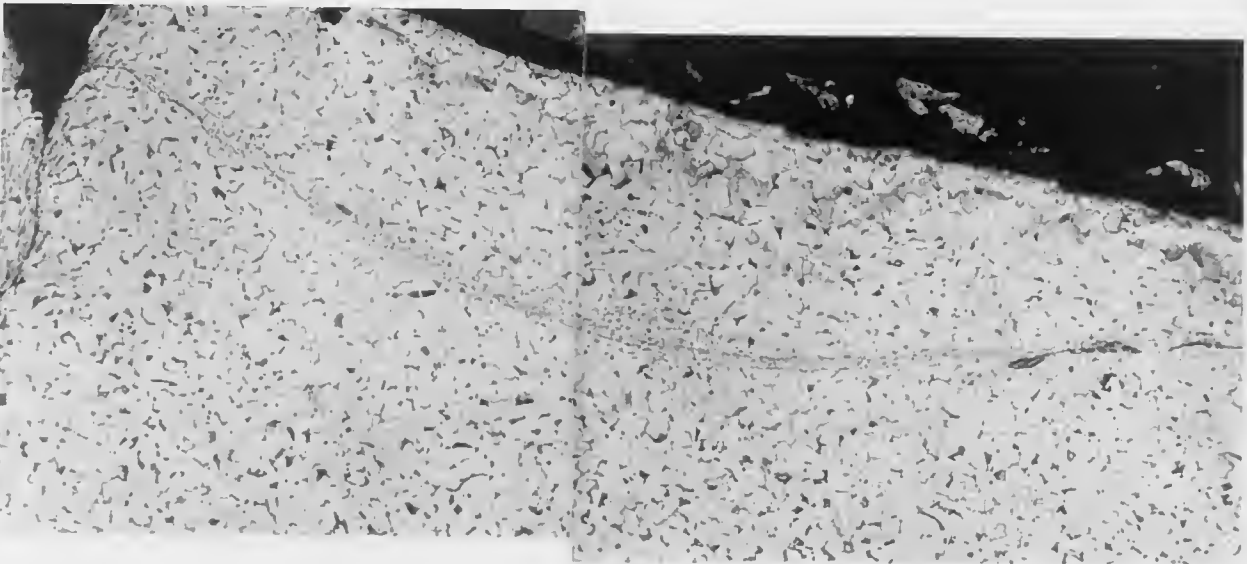
Exhibit A9 -- Metallographic specimen (MS2) taken from the separated ring as shown in Exhibit A5 showing a seam, fold, or thin inclusion extending from the fracture surface (at left) under the gutter surface.

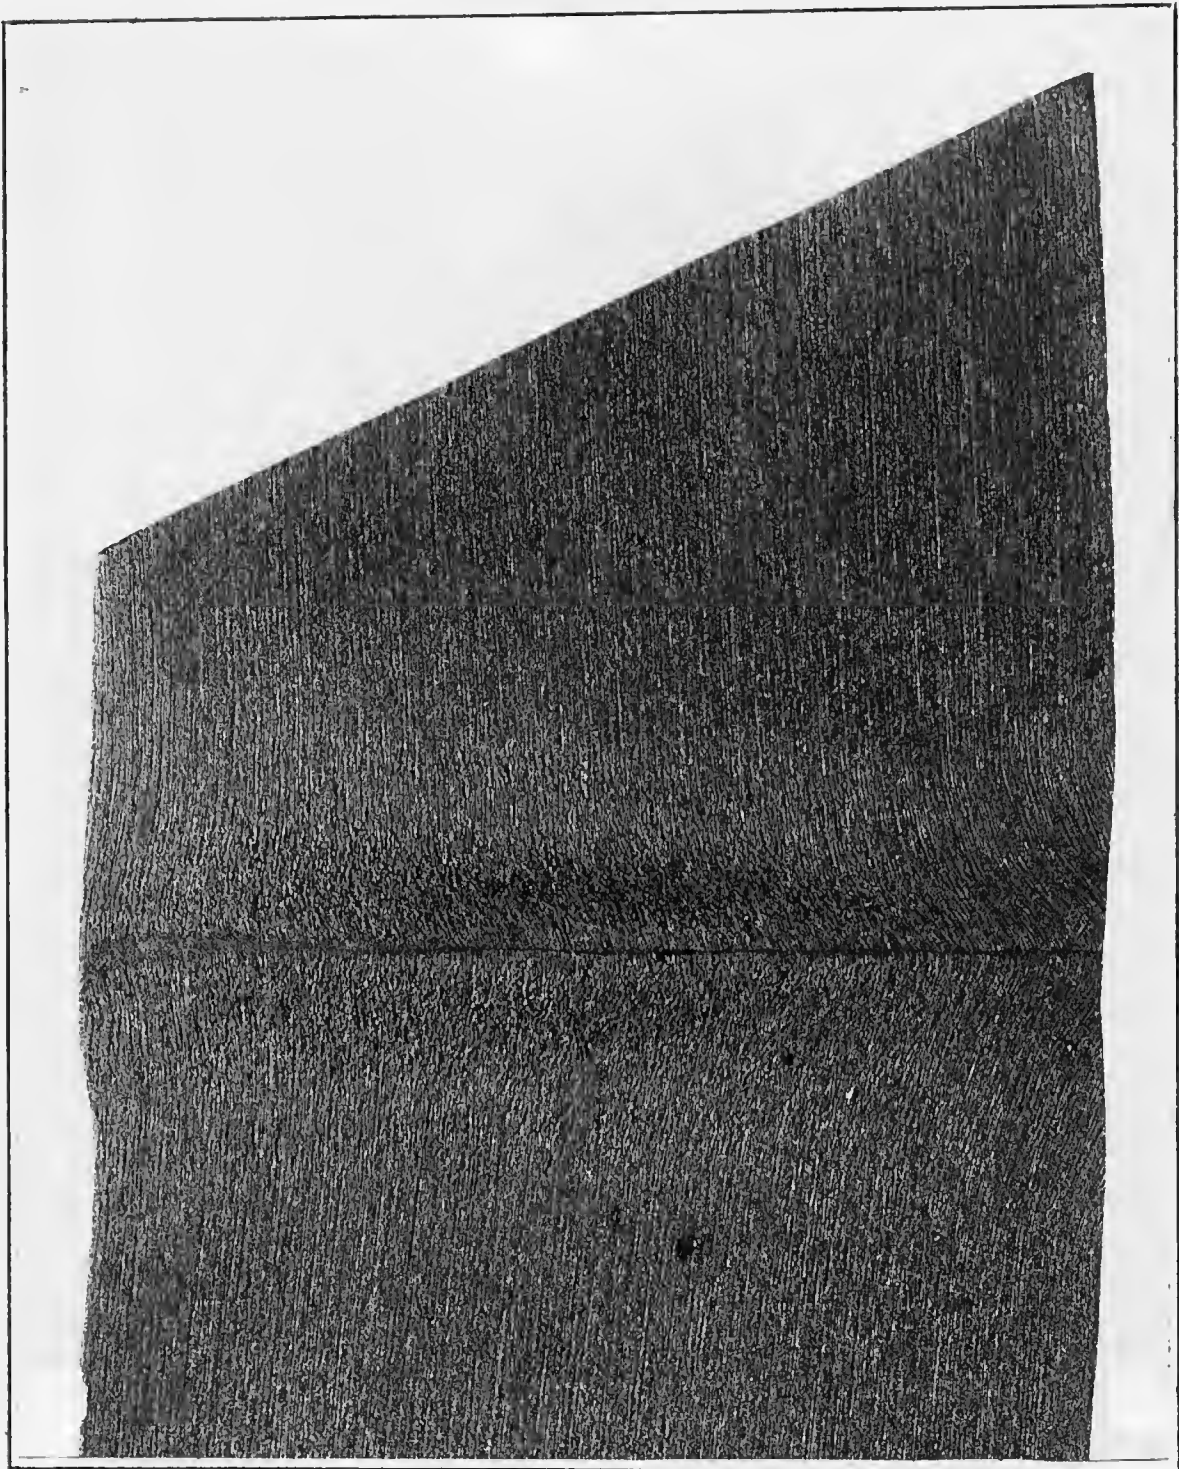
A section of the rim base weld was cut from the separated ring by cutting parallel to the original edge surface of the ring and on the "back side" of the specimen shown in Exhibit A5. This specimen was polished and macroetched as shown in Exhibit A10.

Exhibit A10 -- Photomacrograph of cross-section of weld in rim base showing flow lines in plate, flow lines at weld interface, and interface between the two sections welded together. Approx. 4X

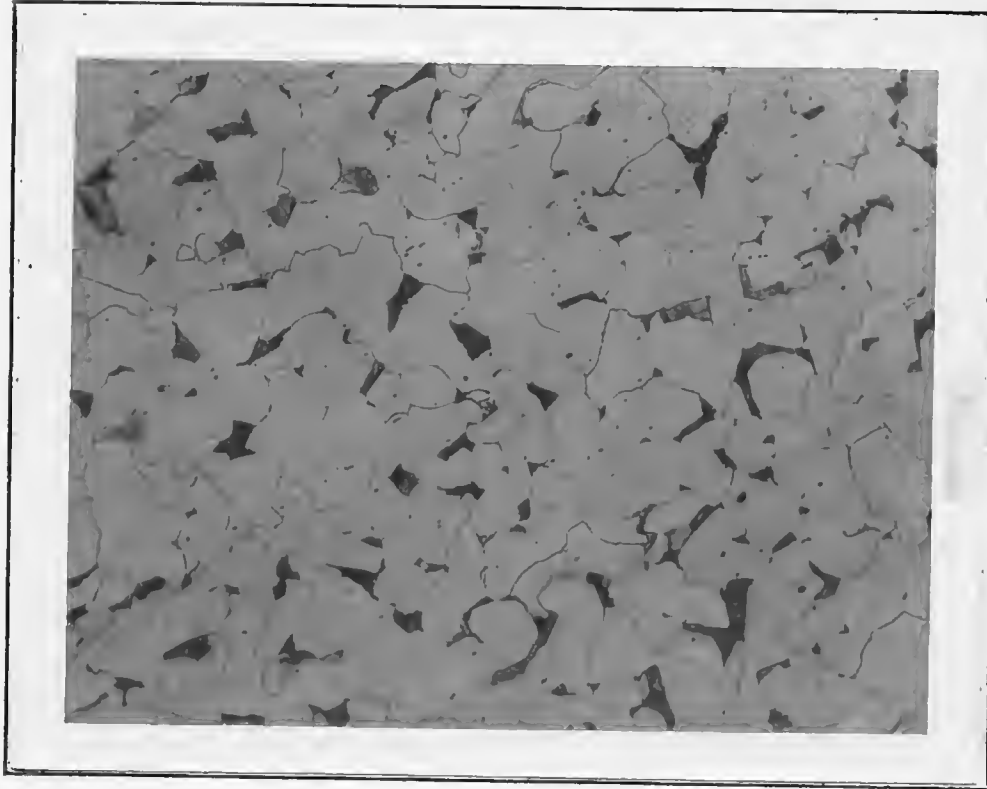
Spectrographic and wet chemical analyses indicate the steel was an AISI 1010. Typical microstructure of the steel is shown in Exhibit A11.

Exhibit A11 -- Typical microstructure of rim base (taken from MS2) showing pearlite in a ferrite matrix.

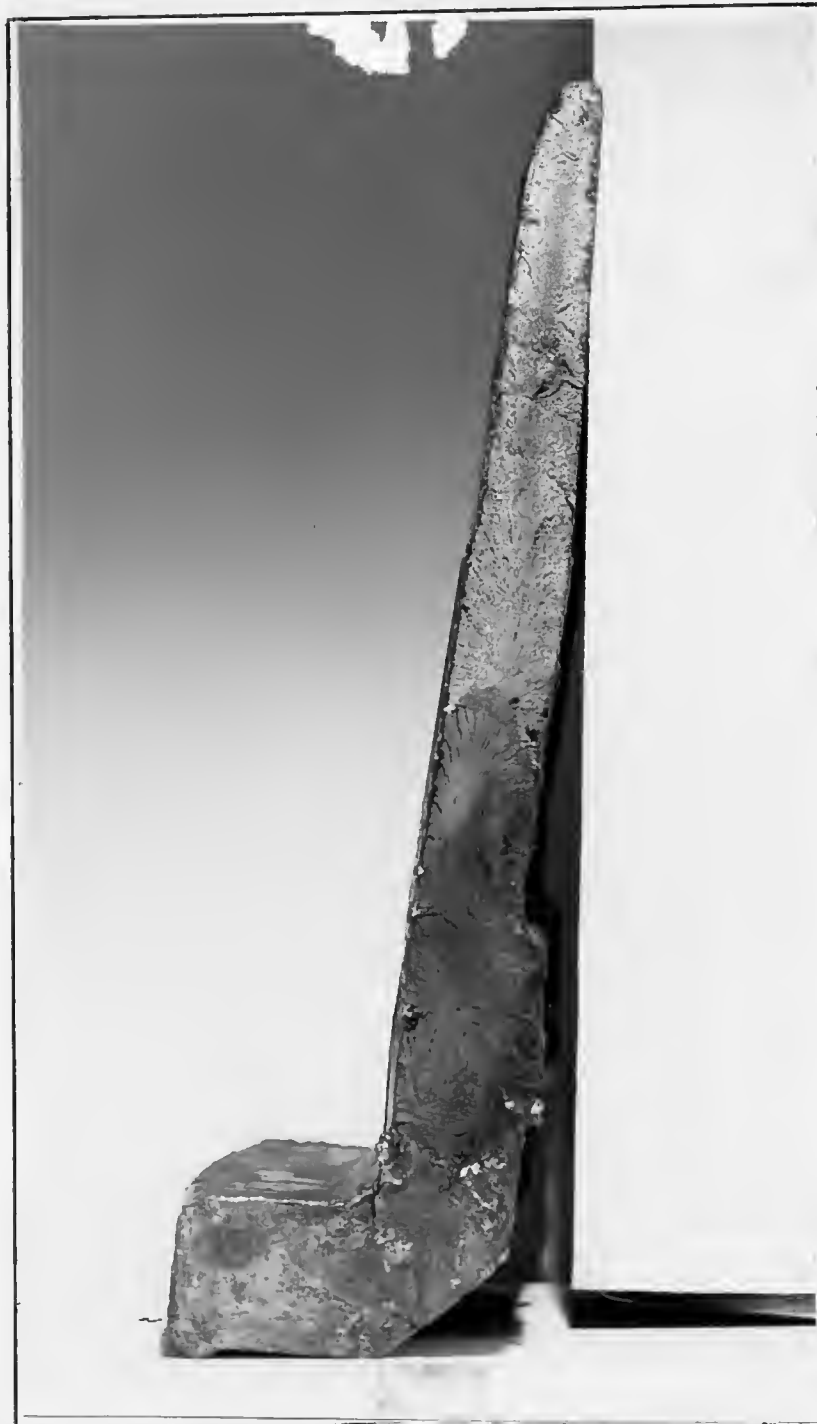
A visual examination was conducted on the tapered bead seat. One view of the fracture surface is shown in Exhibit A12. The shoulder end of this section had a certain amount of "dirt" on it (as-received) which disappeared during handling. There was also some rust in this region and some shiny spots (as if the two fracture surfaces had rubbed together). The center and tapered portions of the tapered bead seat appear to have fractured rapidly. The appearance suggests that some portion of the bead seat had failed prior to the final fracture. Failure was at the weld in the bead seat. The failure surface has been viewed from an angle (Exhibit A13). A small crack and a void are apparent in the weld. It is probable that failure of the bead seat started at this point.

Exhibit A12 -- Fracture surface of the tapered bead seat. The shoulder end shows some rust and some points where rubbing may have occurred. Center section is darkened, perhaps by minor oxidation. Tapered section is bright and shiny. Both the center and tapered sections appear to have failed rapidly. Approx. 1.15X

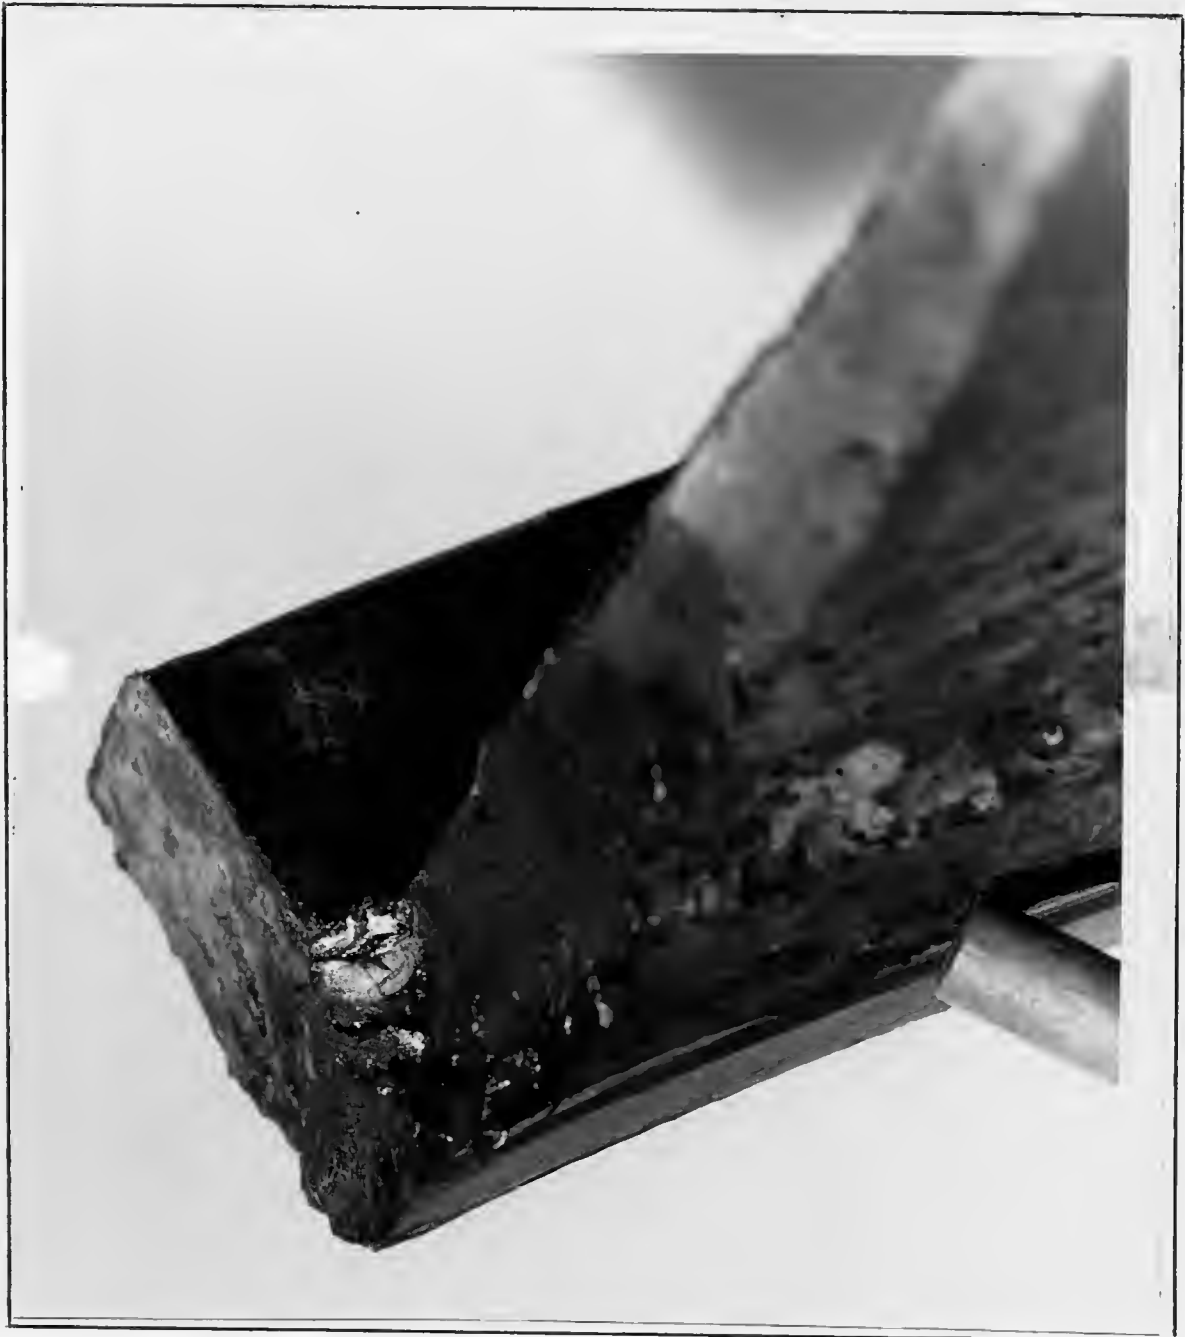
Exhibit A13 -- Oblique view of fracture surface of tapered bead seat showing the weld at the location where the flange retaining shoulder joins with the rest of the bead seat. A crack and a void in the weld are obvious. Approx. 2X.

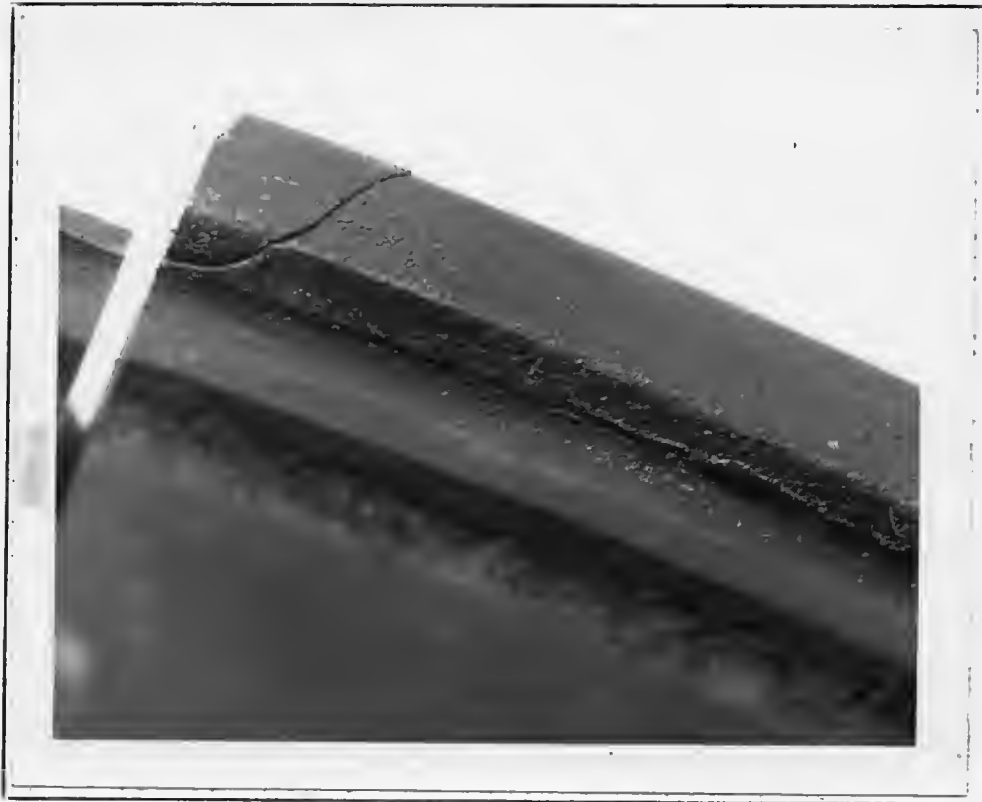
lap or seam on the gutter surface in a section next to one in which there had been separation in the rim base. Faber and Redwine agreed that such an imperfection in the gutter surface could, and very likely did, lead to a fatigue failure in the rim base.

Exhibit D1 -- View of part of the gutter section of a rim base. The presence of a lap or seam is obvious on the gutter surface. A crack is also obvious. This crack is part of a separated surface to the left of a saw cut. The crack appears to be directly in line with the lap or seam.
